Table 4-6 Predicted Construction Noise Levels at Residences – LAeq(15 min) – dBA

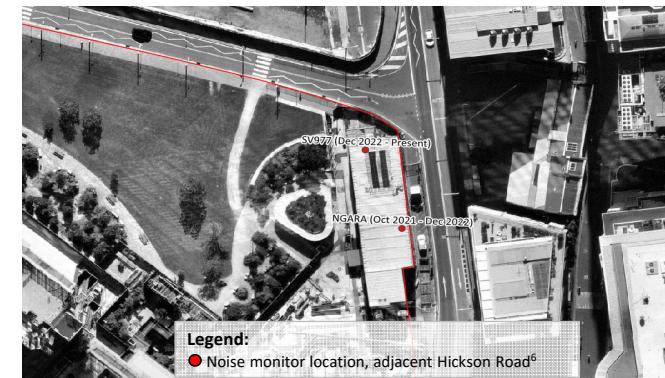
Construction Noise Level ⁴ (Raw Data Only)	
NML ⁵ Exceedance Ranges of 65dB(A) ¹	During Approved Working Hours
<0 dB	96.44%
0 to 5 dB	3.09%
5 to 10 dB	0.43%
10 to 15 dB	0.04%
15 to 20 dB	0.00%
>20 dB	0.00%
	100.00%

Highly Noise Affected NML ⁴ (Raw Data Only)	
NML ⁵ Exceedance of 75 dB(A)	During Approved Working Hours
Non-Exceedance	99.96%
Exceedance	0.04%
	100.00%
